NATURAL HAZARDS

Earthquake Near Chengdu, China

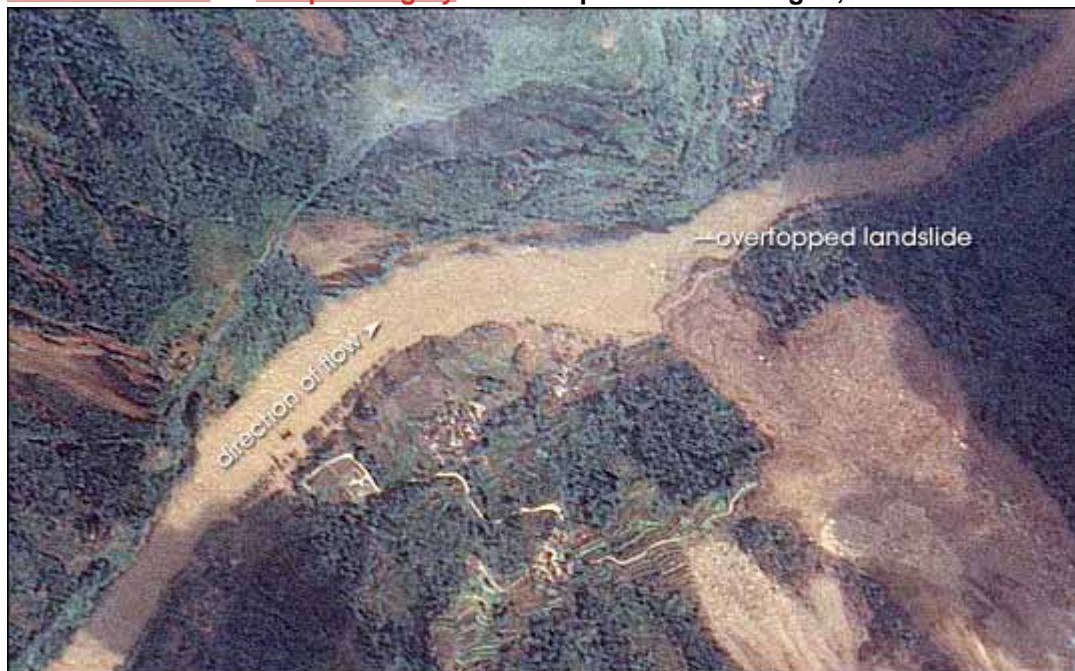
June 10, 2008

The top image, from June 10, 2008, shows a swollen, faster-flowing river after the massive landslide upstream was breached. Compared to the image taken two days earlier, the river is wider, and it has submerged some land features along its banks. Its tan hue indicates that it carries considerable sediment, including sediment from the breached landslide upstream. The flooded river has overtopped the smaller landslide shown in this scene.

On June 10, 2008, Chinese authorities announced that the landslide that created Tangjiashan Lake had been successfully breached, and the lake had safely drained. These natural-color images, acquired by Taiwan ' s Formosat-2 satellite, show changes in the Jiangjiang River—downstream from the lake—before and after the intervention.

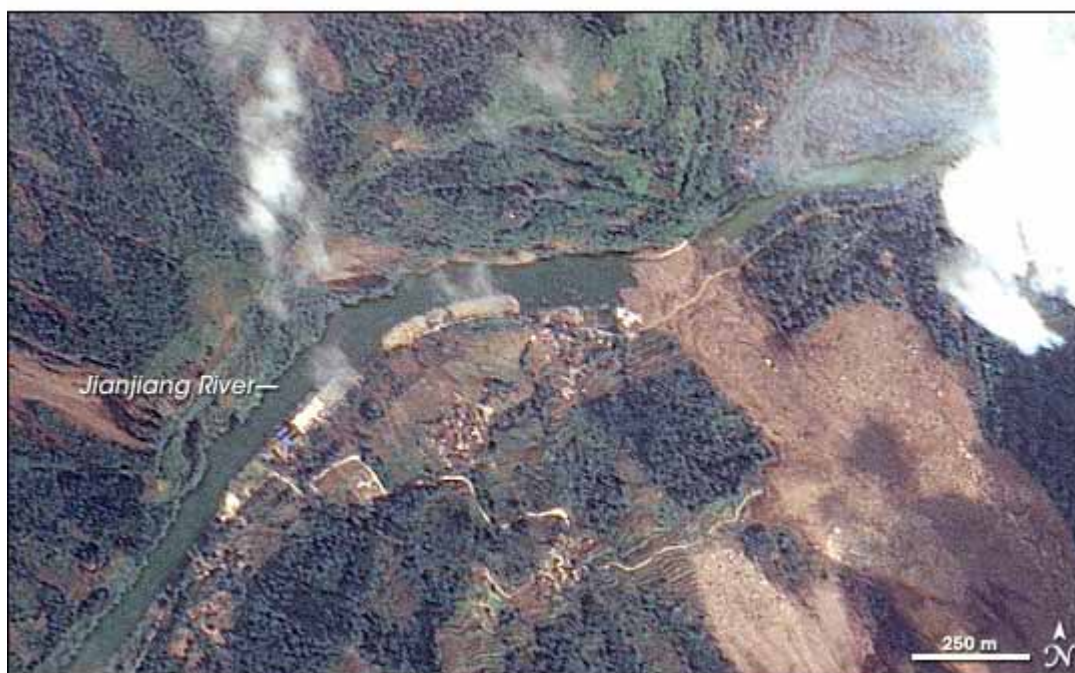
June 8, 2008

The bottom image, from June 8, 2008, shows the apparently slow-moving river, hampered by landslides both up- and downstream (river direction is from left to right). A landslide appears in this scene, and a small sluice (thin, off-white line) appears to have been cut across it to allow water to pass. Some water flows through the river channel downstream.
